Old House

Back to Basics

A Pennsylvania couple turns back the clock on their 18th-century farmhouse by removing multiple layers of misguided updates.

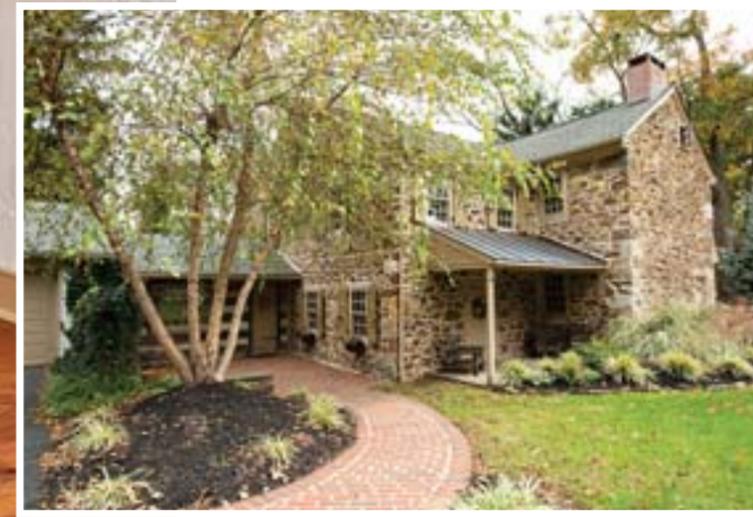
LEFT: The Dolans painted the living room's new fireplace surrounds in historic colonial-era colors. **ABOVE:** To complement the newly uncovered stone façade, the breezeway's vinyl siding was replaced with salvaged hand-hewn log siding.

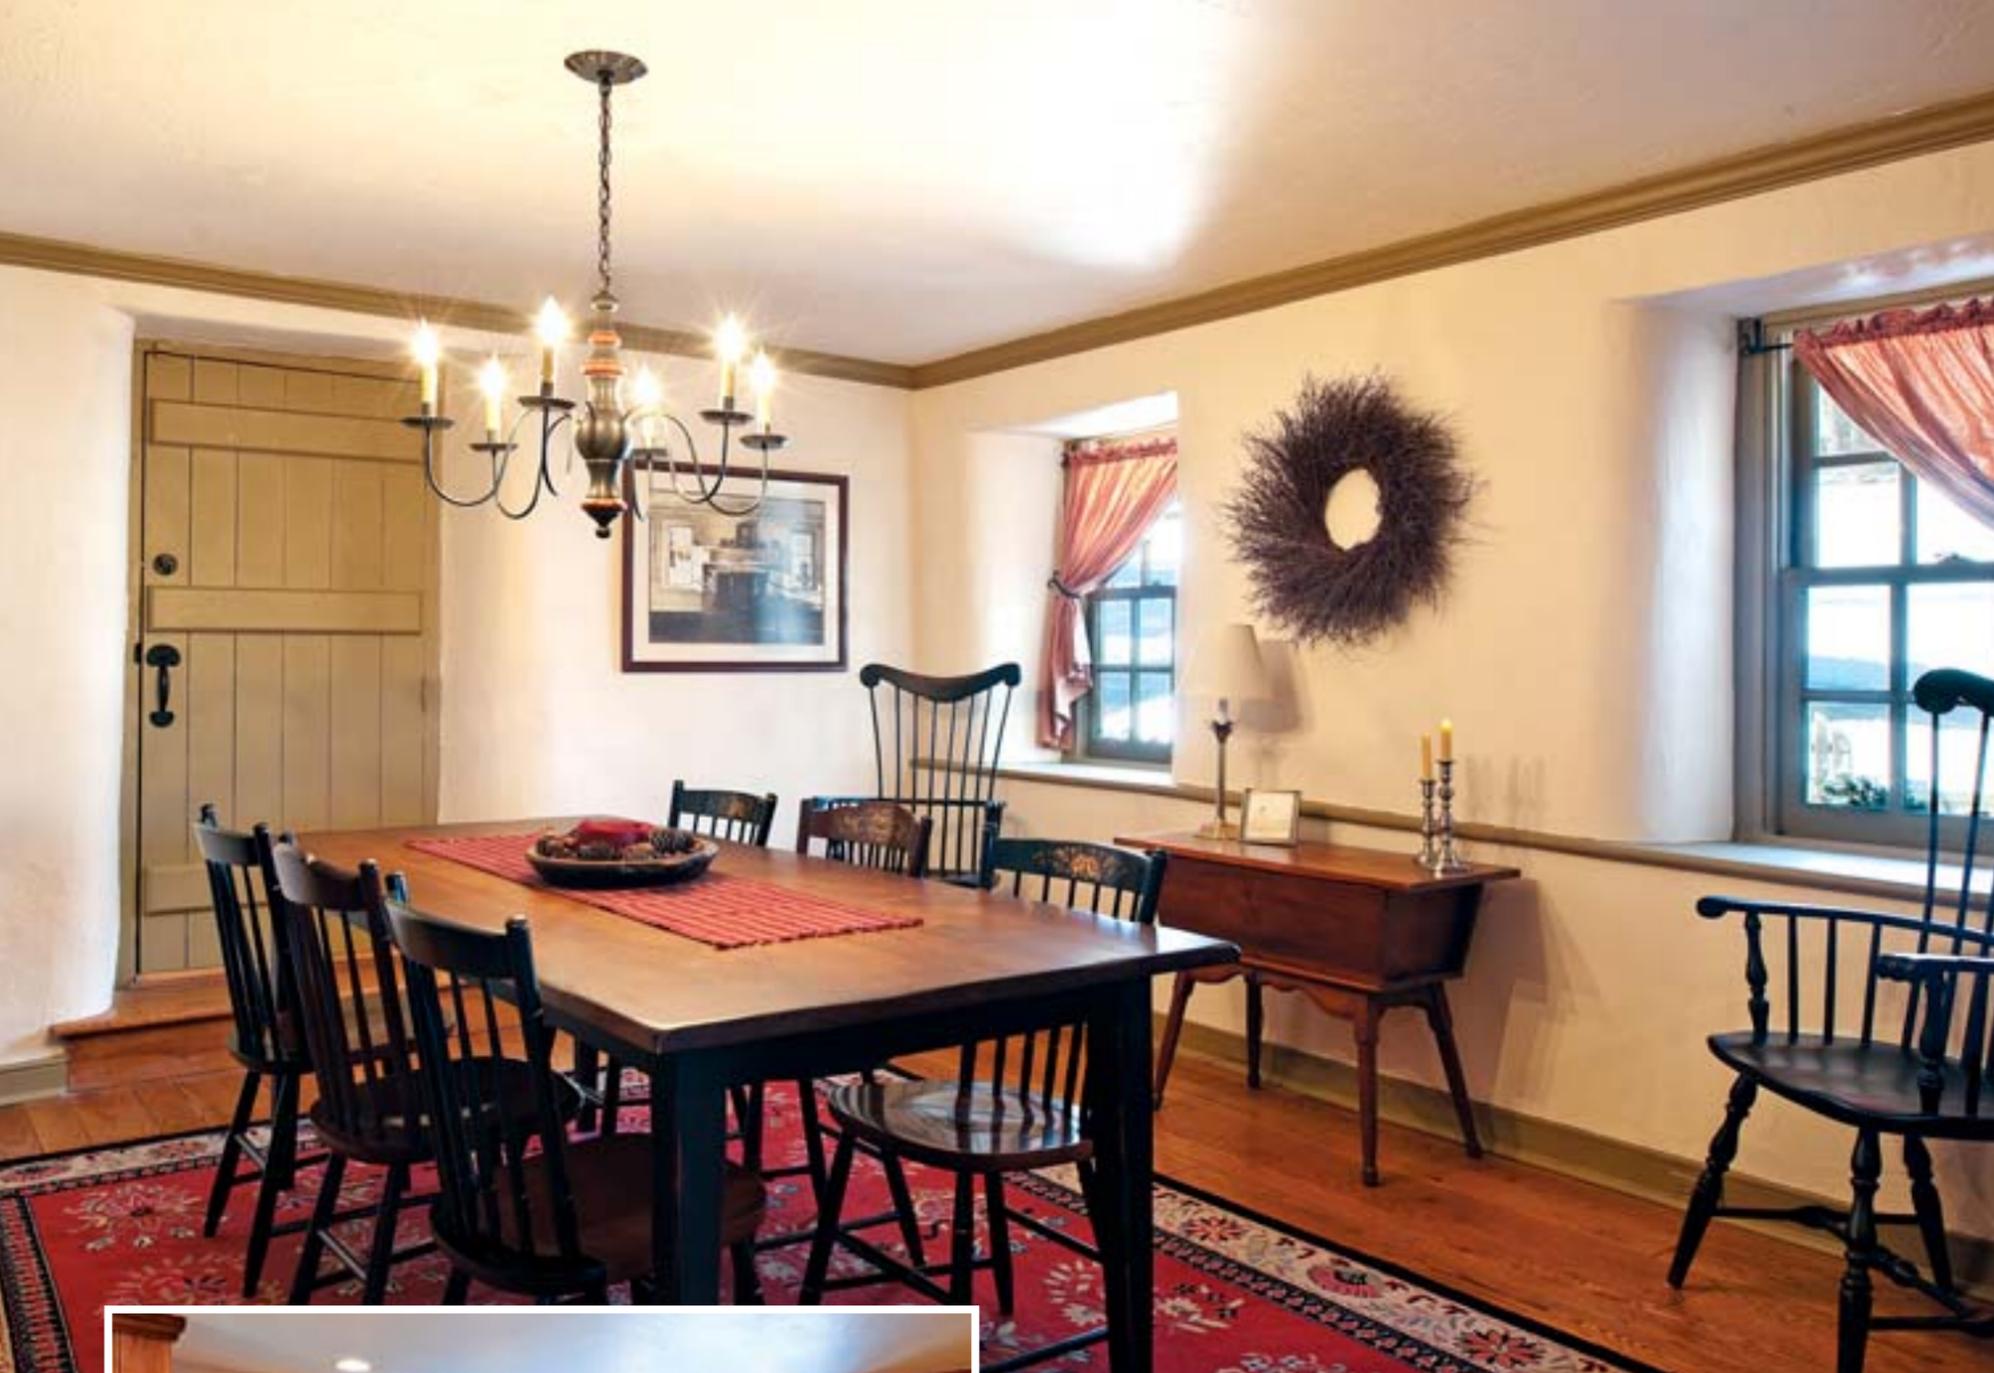
LEFT & BELOW: Kevin McGinnis removed unsympathetic paneling and created new fireplace walls. The door at left hides an office cubby with the family computer. **OPPOSITE, TOP:** In the dining room, plasterer Jack Thompson maintained the traditional curves around the windows and doors, called “witches’ corners.” **OPPOSITE, BOTTOM:** When Mike and Kathy bought the house, the kitchen had been split into two rooms; they opened it back up by removing a pantry.

Also original to the living room are the twin fireplaces flanking the space, which had been remodeled with unsympathetic surrounds. Jeff used his knowledge of similar homes of the same era to design replacements. Although today the room is one large, open space, “we think this would have originally been a two-bay, three-room house,” he explains, “so they would have done different treatments for the fireplaces on each side of the building.” For the dining side of the room, cabinetmaker Kevin McGinnis (Mike and Jeff’s cousin) made a raised-panel surround, while the living-room side features tongue-and-groove paneling.

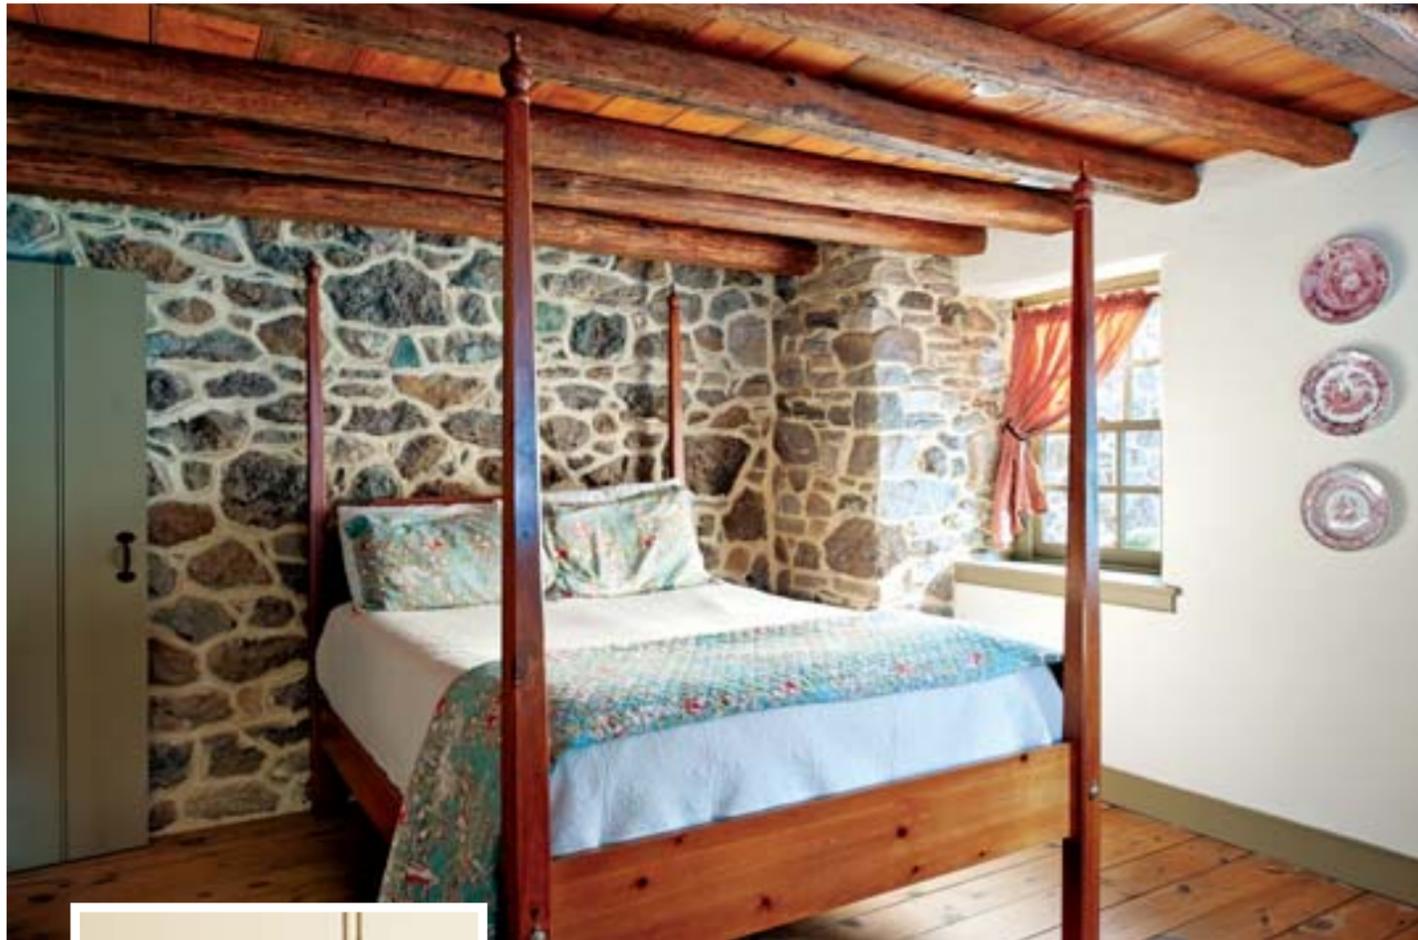
ABOVE: The master bedroom's exposed stone wall contains a flue for the dining-room fireplace, which was too damaged to save. **LEFT:** A restored antique door latch by Monroe Coldren & Son adds a note of authenticity to the stairwell door.

When removing deteriorated plaster walls, they uncovered stone matching the house's exterior underneath one wall, evidence that the master bedroom and dining room below were a later addition to the house. They left the wall exposed,

and Mike seized the opportunity to drill channels within it to run electrical wires. Plasterer Jack Thompson then re-plastered the bedroom's other three walls with a slightly textured finish. "It would have been easy to put up drywall," says Mike, "but we wanted them refinished like they would have been originally."

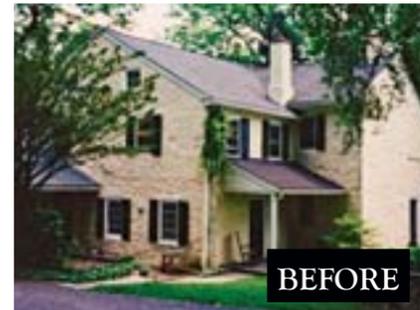
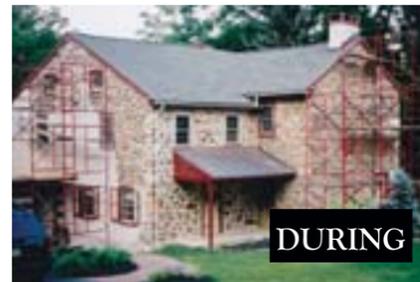
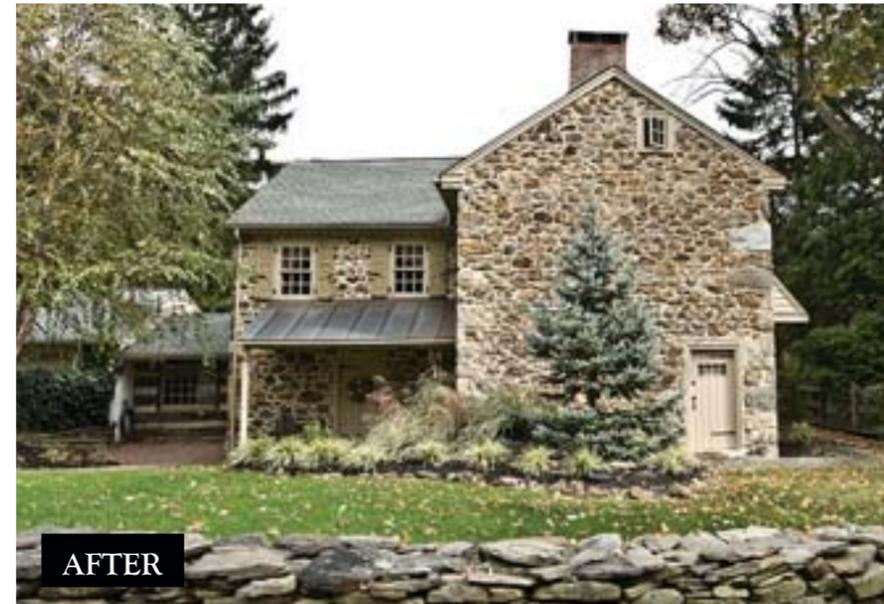
ABOVE: Removing the stucco from the house's stone exterior took mason Cleveland Ambris three months. Beneath the stucco were pitted fieldstones, accented on the corners by massive irregular stones. **BELOW:** Hardwood floors, beadboard paneling, and traditional décor help the family-room addition blend with the rest of the house.

Another major layer that needed to be removed was the white stucco encasing the exterior, which Mike and Jeff suspect was added to avoid having to repoint the historic lime-based mortar. Based on the home's age, Mike guessed that the stucco façade might be harboring stone underneath, but he wasn't quite sure what he'd find when he chipped a piece of it away with a ham-

mer. "On a lot of houses of this period, the corners might be really nice, but the middle might be brick or inferior stone," he explains. After stonemason Cleveland Ambris had removed a full wall's worth of stucco, Mike was relieved to see that the house was a uniform fieldstone with a distinctive pitted texture. "It's almost like lava rock," says Jeff. "I've never seen stone like this before."

Working single-handedly, Ambris carefully chiseled off all the stucco, then repointed all the joints with a lime-based mortar mix based on samples of the old mortar, carefully replicating the original crown point. "The entire process took him about three months," Jeff says.
